# Maine Forestry Best Management Practices (BMP) Use and Effectiveness—Data Summary 2016-2017

Maine Forest Service  
*Forest Policy and Management Division*

Published April 2018

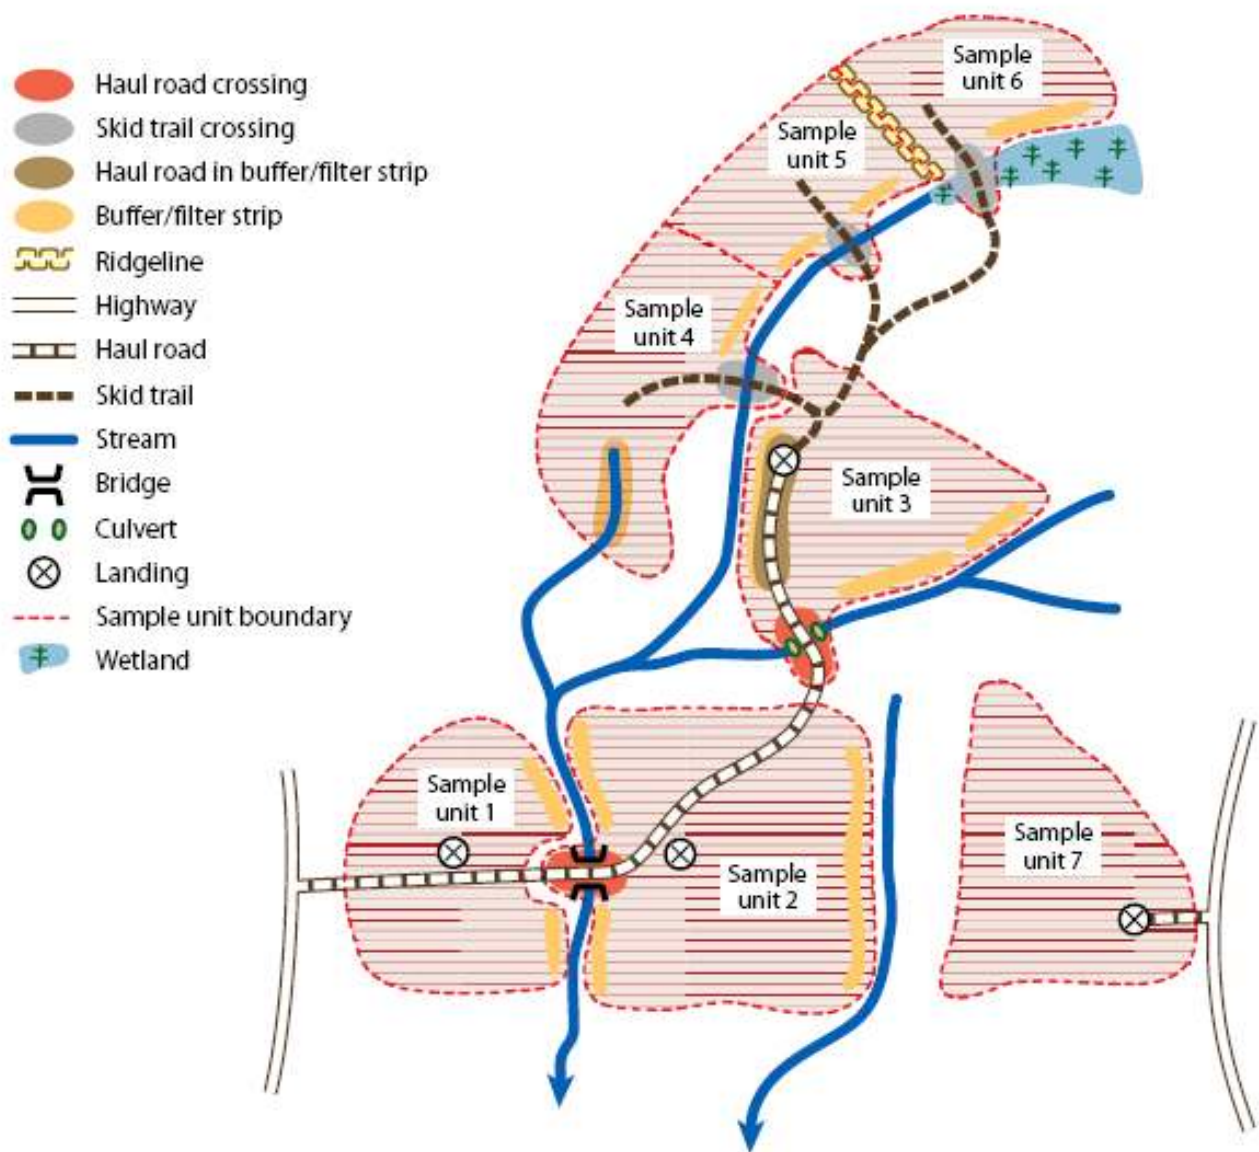
**Figure 2.** Depiction of possible sample unit delineation.

MFS personnel focused on recently harvested areas adjacent to surface water, as these were considered high risk areas in terms of sedimentation. Sample units were delineated by harvesting boundaries, ownership boundaries, and by the crossing of natural perennial and intermittent streams. The crossings and their approaches were inspected for BMP implementation and effectiveness and the data was recorded for each sample unit as the water body was being crossed. The delineation of sample units and the features to be included within them are shown on figure 4.

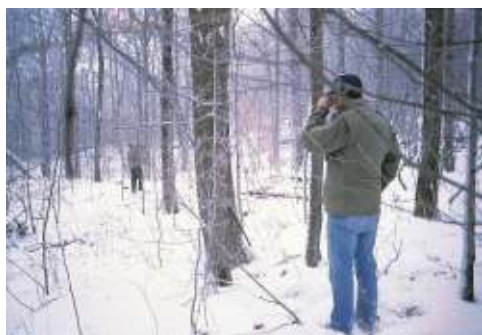
*Laying out the harvest on the ground can help identify sensitive areas, reduce skid trails, and avoid unnecessary stream crossings.*

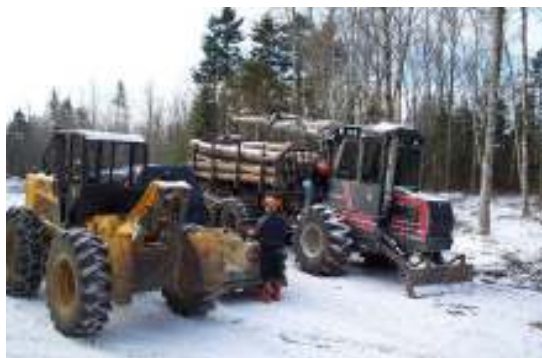
*When used properly, carried wood systems (e.g. the forwarder seen on the right) can result in less soil disturbance vs. dragged wood systems (e.g. the cable skidder seen on the left). Regardless of the type of system used, operator skill and training together with proper planning are critical to good results.*

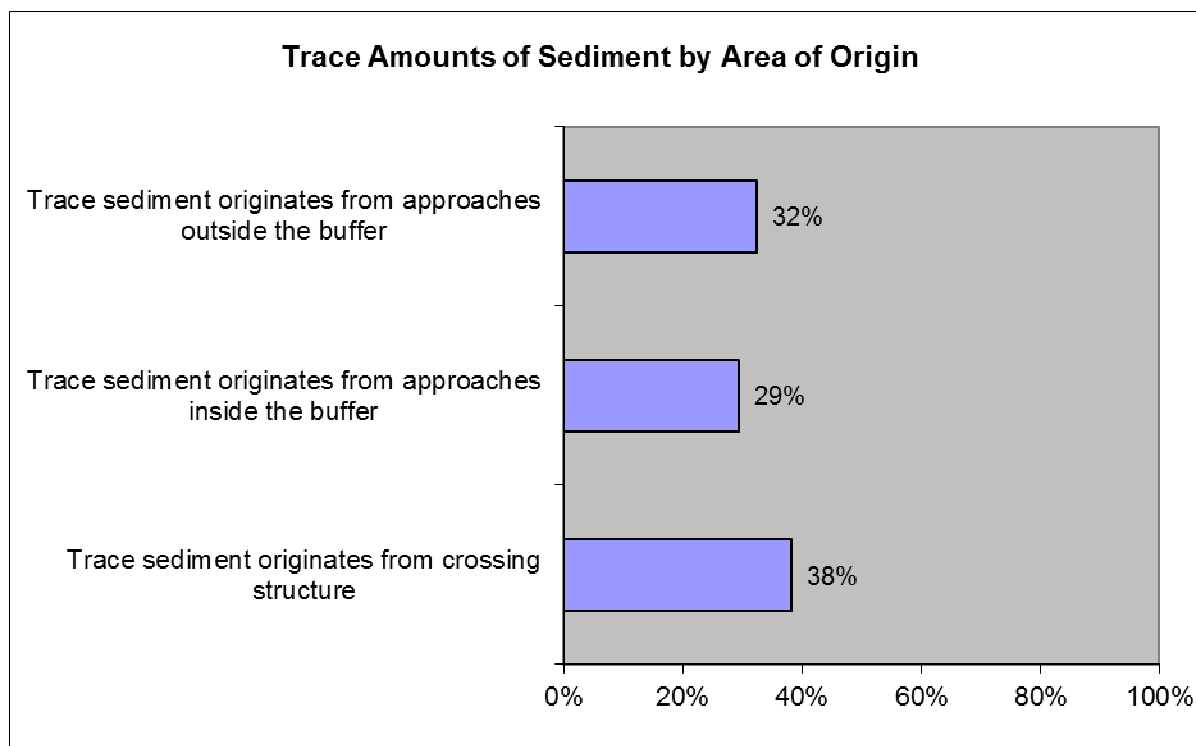
**Figure 12.** Trace amounts of sediment by origin. Proportions are based on the total number of opportunities to observe soil conditions (n=34).

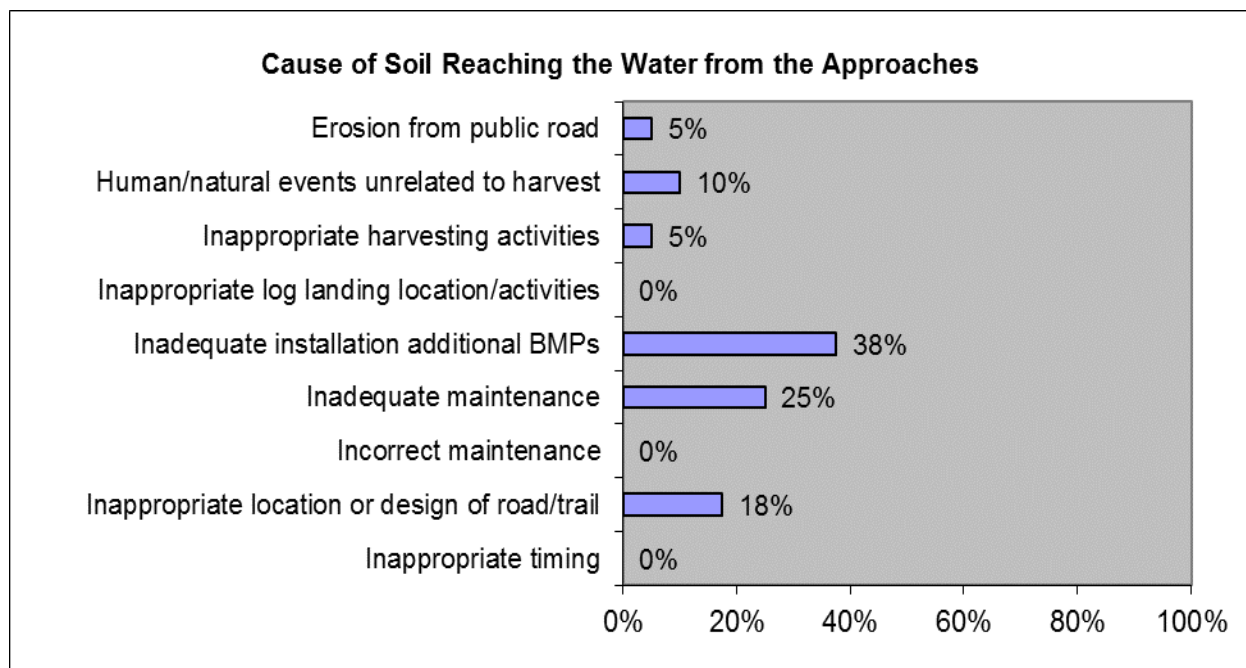
**Figure 15.** Cause of soil reaching the water from the approaches (n=45).

BMP Maintenance refers to reshaping or reinforcing installed BMPs to compensate for wear from use, erosion or in anticipation of seasonal shutdown or extreme weather events. Inadequate installation of additional BMPs or inadequate BMP maintenance are the primary causes for sediment reaching the water from the approaches (Fig. 15). This finding is consistent with previous years and should continue to be emphasized in trainings and workshops.

- 1) **Plan ahead** - avoid water crossings, locate access roads, landings and trails properly, and time operations appropriately;
- 2) **Build it right** - adequately apply initial BMP installations;
- 3) **Maintain it** - monitor, repair and add additional BMPs as necessary during the active portion of the harvest; and
- 4) **Close it out properly**- identify long-term maintenance and monitoring needs, successfully establish soil stabilization, and anticipate activities unrelated to timber harvesting that may degrade final stabilization efforts.

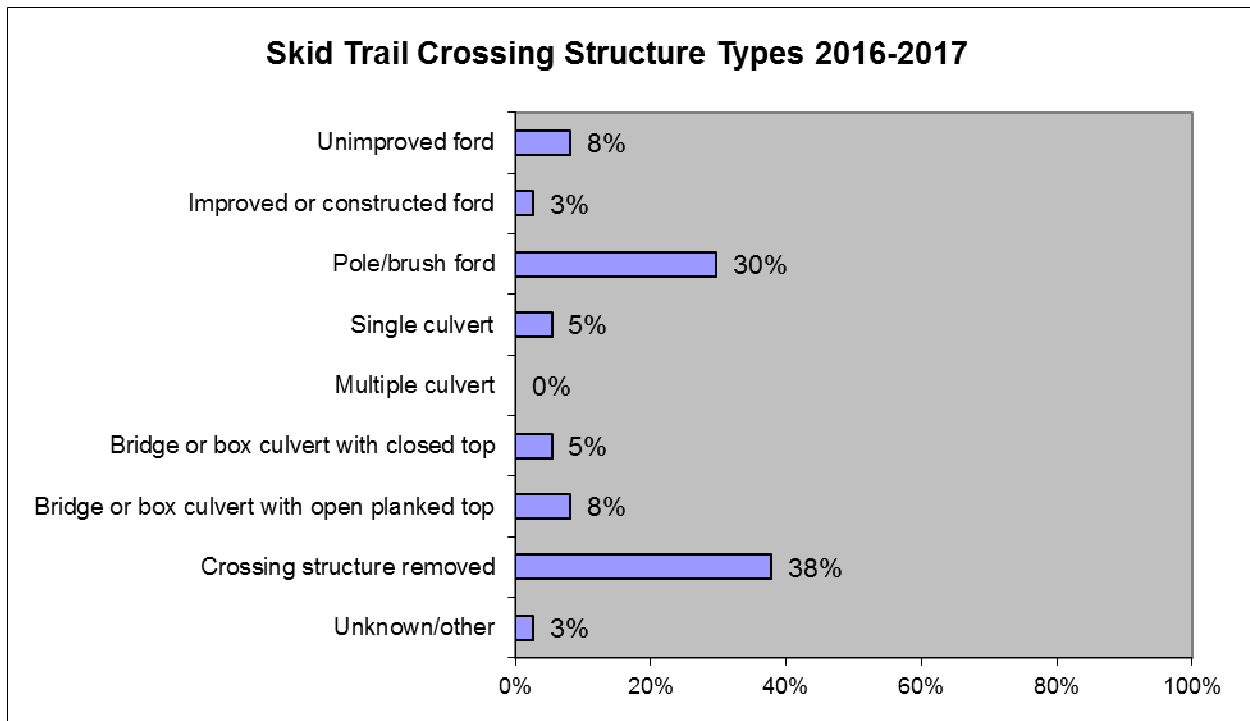
**Figure 18.** Structure type associated with skidder crossing. Proportions are based on the total possible number of crossing structures (n=40).

Skid trails were much more likely to use temporary crossing measures (71%), especially pole/brush fords and other structures removed at the time of monitoring. Bridges accounted for 13% of skid trail crossings, though monitoring did not distinguish between temporary and permanent bridges. Temporary skidder bridges are an effective crossing method increasingly in use, but do not yet represent the majority of skidder crossings.

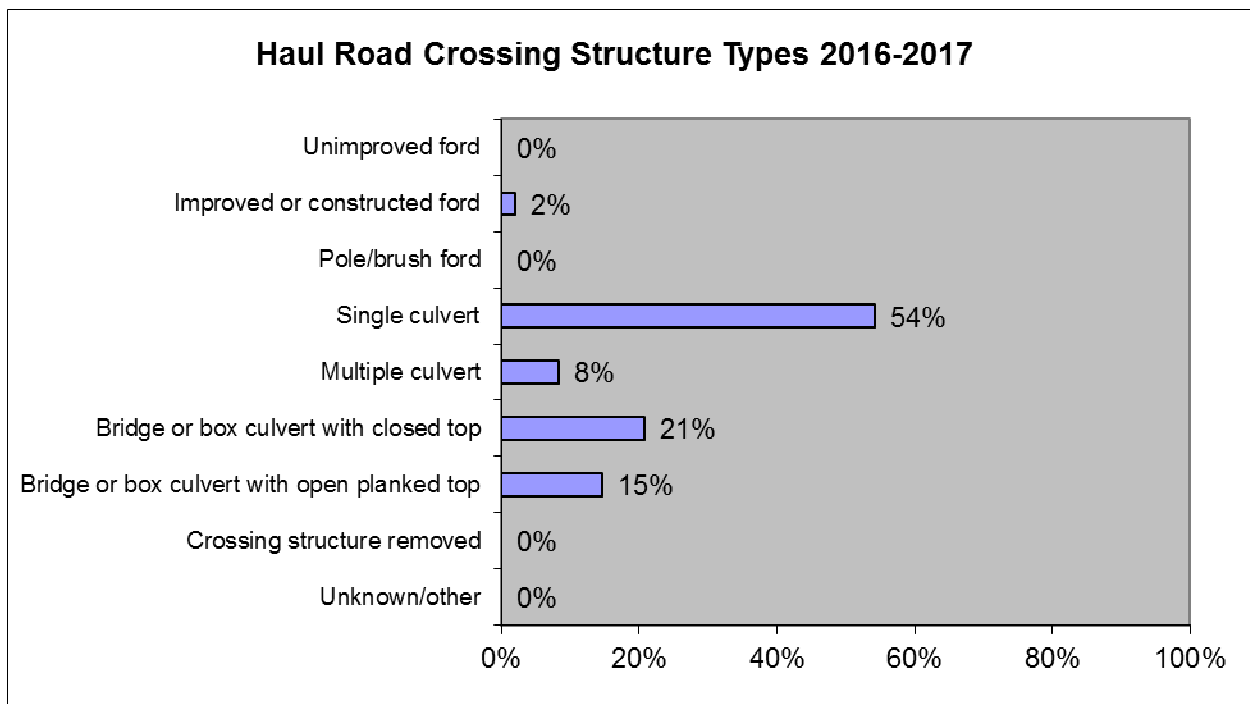
**Figure 19.** Structure type associated with haul road crossing. Proportions are based on the total possible number of crossing structures (n=49).

Haul roads were more frequently permanent crossings, using conventional structures such as bridges or culverts. There were no observations of temporary haul road crossings that had been removed.

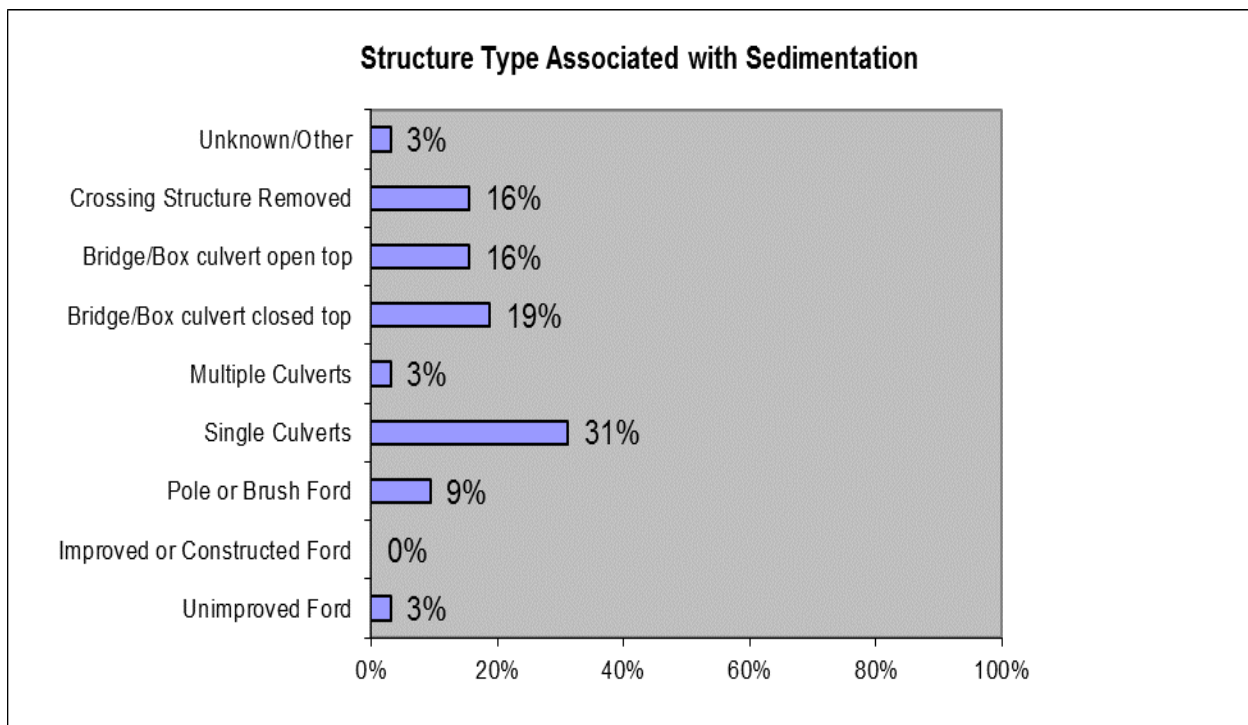
**Figure 21.** Structure type associated with sedimentation (n=31).

When measurable sedimentation was observed at the crossing structure, the structure type was most often a single culvert. However this does not indicate the relative risk of sedimentation occurring since single culverts were also the most commonly evaluated structure. To assess this risk, each structure type was analyzed separately to see how often sedimentation occurred for that type. Note that the monitoring methodology does not address sedimentation events/amounts that are not observable at the time of monitoring.

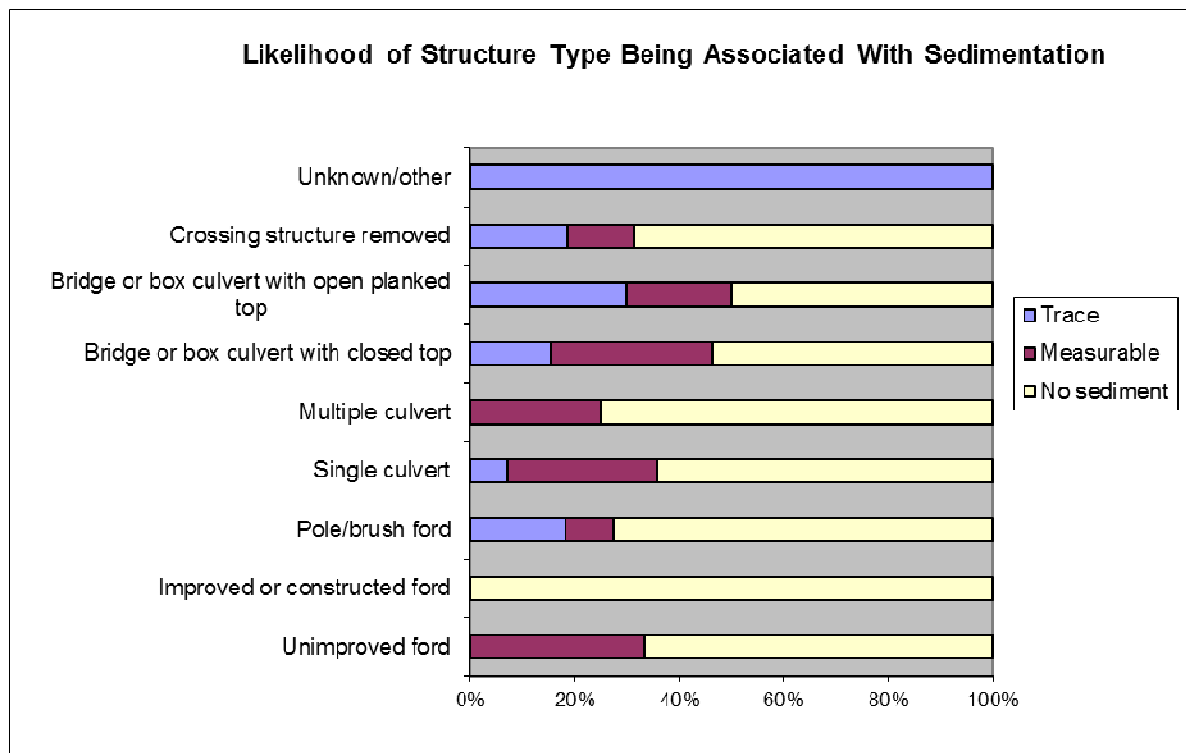
**Figure 22.** Likelihood of structure type being associated with sedimentation.

The likelihood of a structure to contribute to sedimentation is directly related to the occurrence of the structure during our monitoring efforts (Fig. 22). For instance, multiple culverts were observed only 4% of the time. However, measurable amounts of sediment were reported during this rare occurrence, resulting in a high likelihood of this structure type being associated with sedimentation. Figure 22 suggests that using multiple culverts, or unimproved fords to cross streams is less effective than other methods at preventing sedimentation. Please refer to Figure 17 to view the occurrence of each structure.

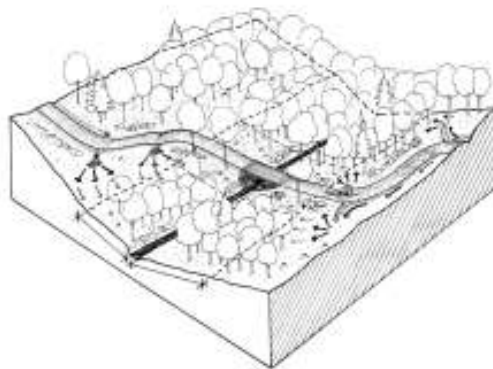
Crossings located at the lowest point of the road profile can fail prematurely from side embankment erosion immediately adjacent to the structure.

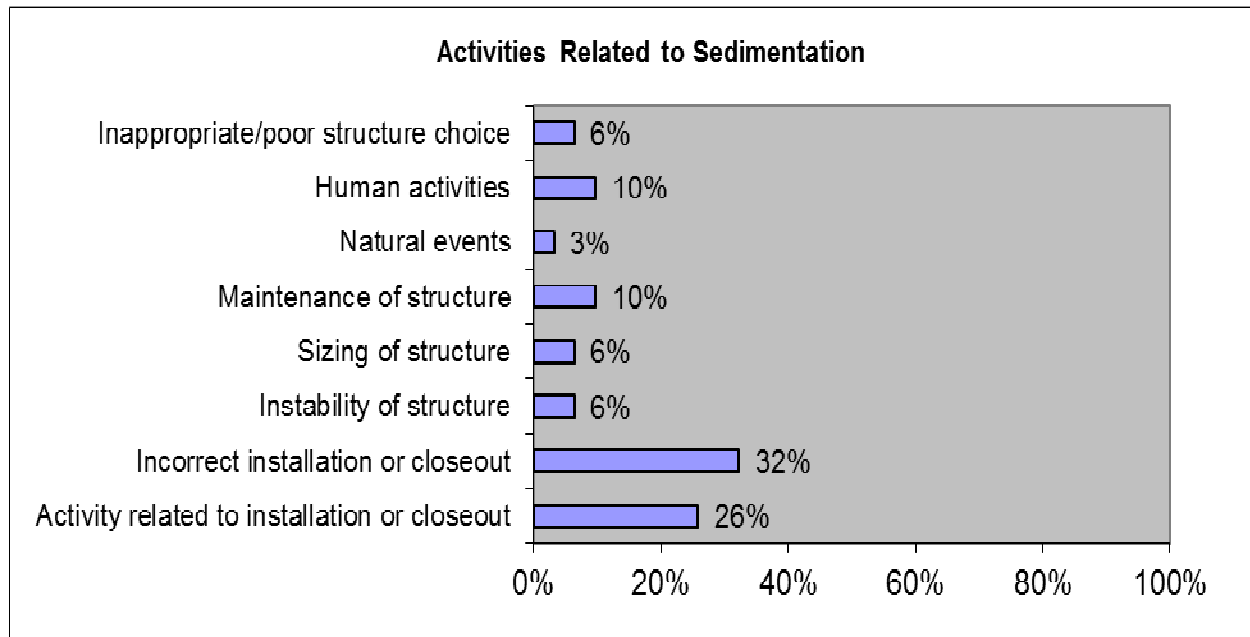
**Figure 23.** Activities related to sedimentation at crossings (n=31).

BMPs are designed to be reasonable measures to minimize the amount of sedimentation that occurs. Installation or closeout of crossings were the most common causes of sediment entering the waterbody from the crossing structure. It is very difficult to install or remove a crossing without some level of sedimentation occurring. A small, one-time input of sediment from a crossing removal or installation is often of less biological importance than ongoing, chronic sediment inputs. **Use of stabilization BMPs after removal or installation are critical to ensure that chronic sedimentation inputs are avoided.**

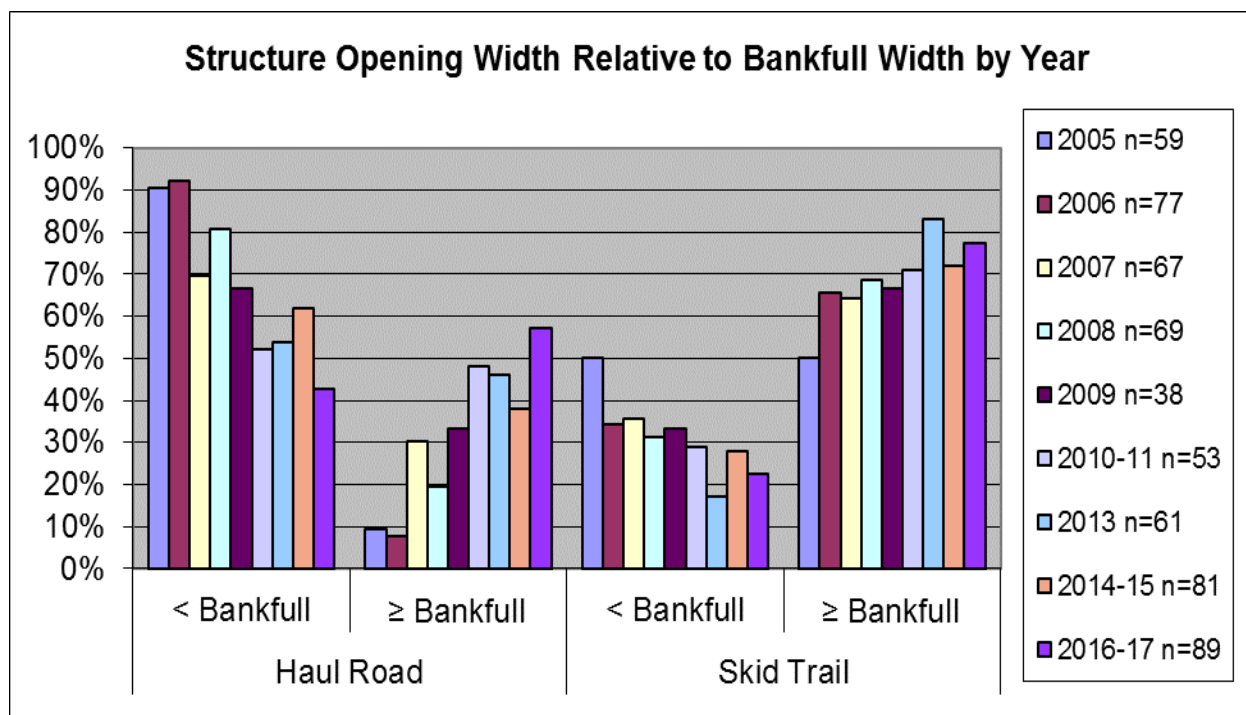
**Figure 26.** Crossing structure widths relative to stream bankfull width. Data includes remnant structure width for structures that have been removed prior to the monitoring field visit.

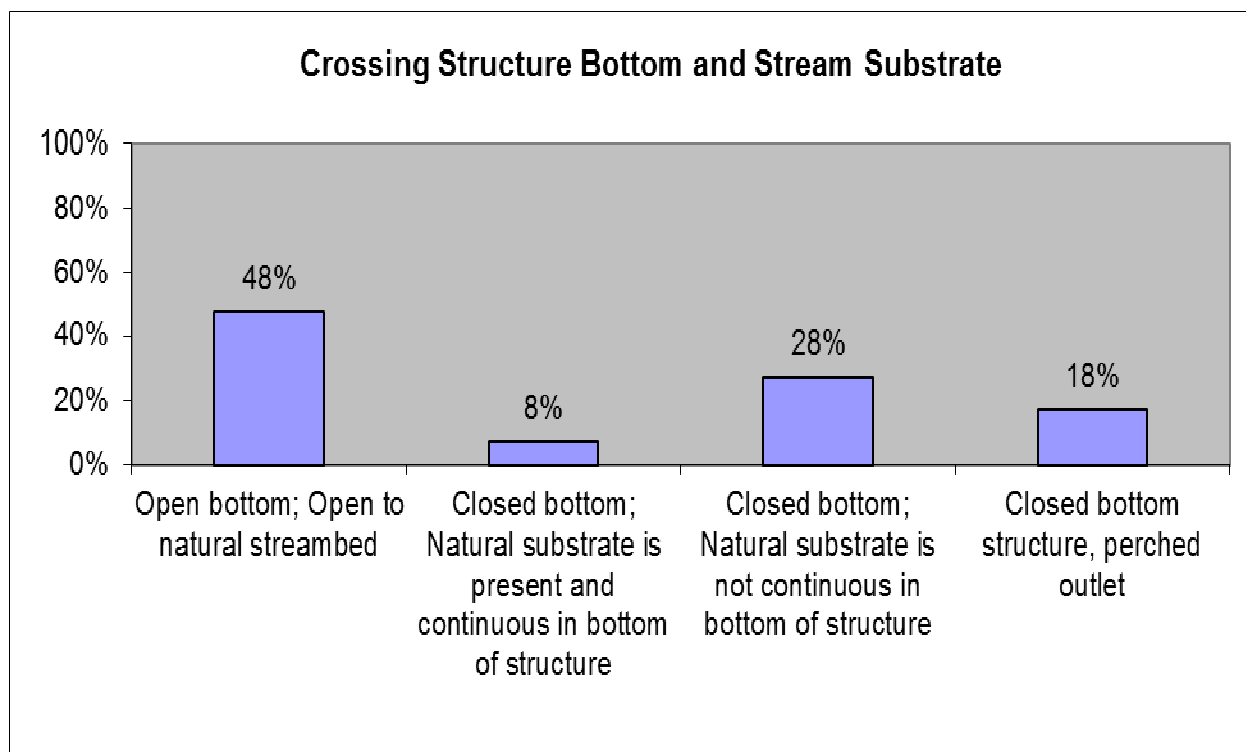
**Figure 27.** Crossing structure bottom condition for crossings where fish or macroinvertebrates were present and the structure was to be in place for more than 3 months (n=40).

It was found that 18% of stream crossing structures where fish or macroinvertebrates were present and the structure was to be in place for more than 3 months had perched outlets, indicating a problem with the elevation of the installation and/or under sizing of the crossing structure (Figure 27). Twenty percent (20%) of crossings had scour within 100 feet downstream of the crossing (Figure 28). Scour can result from flow accelerating through an undersized crossing and eroding the stream bed downstream. Multiple culverts and single culverts were the most common structure types to exhibit scour, whereas temporary structures such as constructed, pole or bush fords were less likely to have scour associated with them (Figure 29).

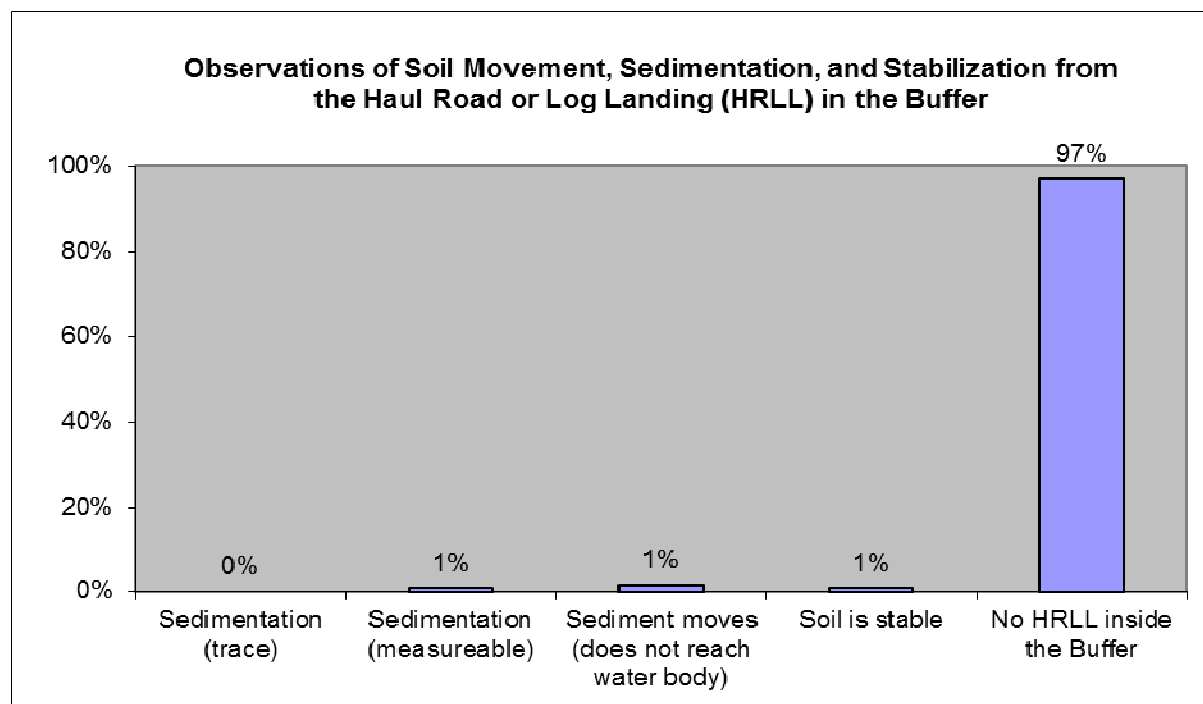
**Figure 30.** Proportions are based on the total number of opportunities to make observations about soil conditions at haul roads or log landings inside the buffer/filter strip. Sites with no surface water present were removed from this analysis (n=134).

As with other findings, analysis shows when BMPs are applied, negative impacts to forested water resources are greatly reduced. Locating haul roads and landings outside the buffer during the pre-harvest planning is an effective BMP commonly implemented by Maine forest practitioners.

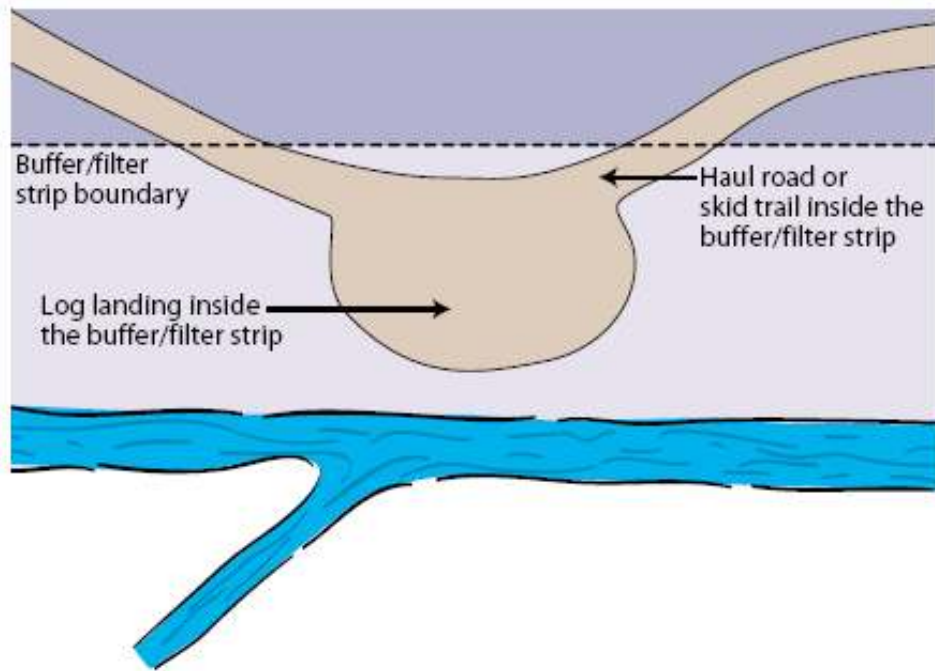
Selecting haul road and landing locations carefully can minimize risk to sensitive areas

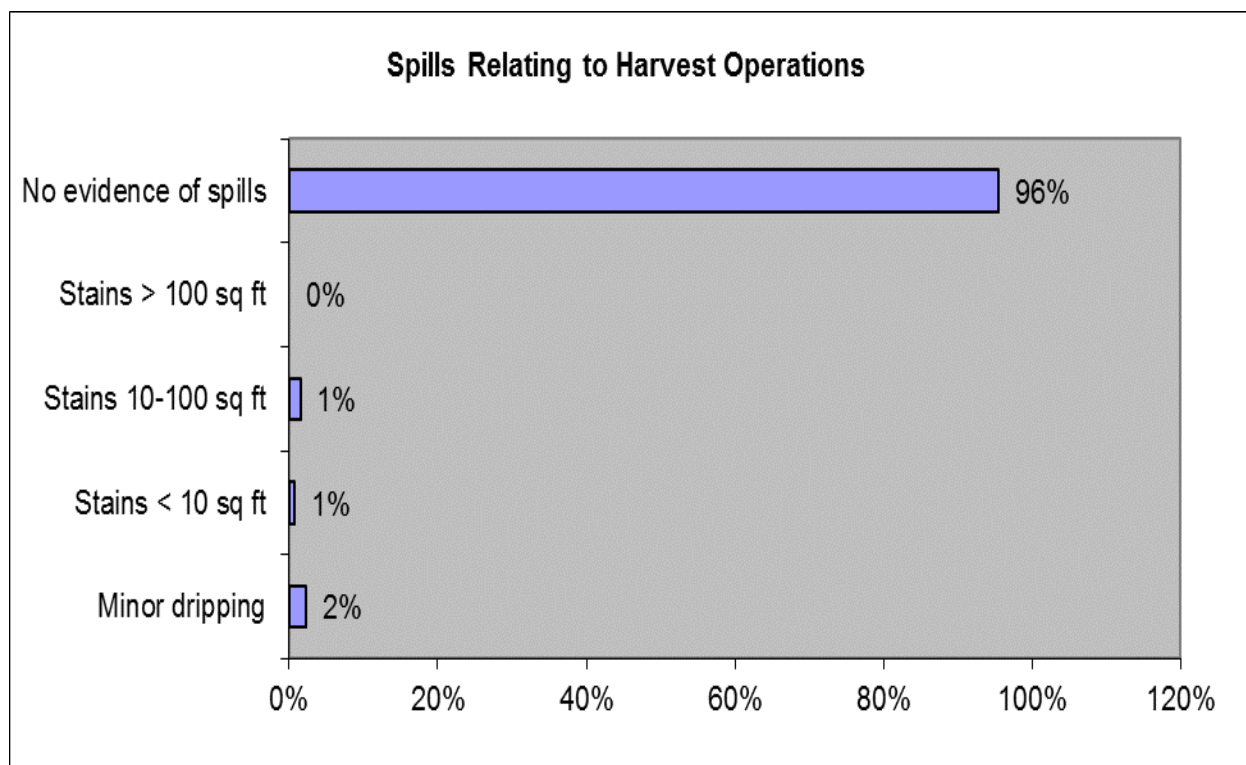
**Figure 31.** Spills relating to harvest operations (n=134).

- **6** sample units had evidence of lubricant, fuel, hydraulic fluid, and/or anti-freeze spillage resulting from harvest operations.
- **4** sample units had evidence of discarded batteries and/or other potential pollutant containers present.
- **None of the** sample units had evidence of chemical spills as well as discarded batteries and/or other potential pollutant containers present.

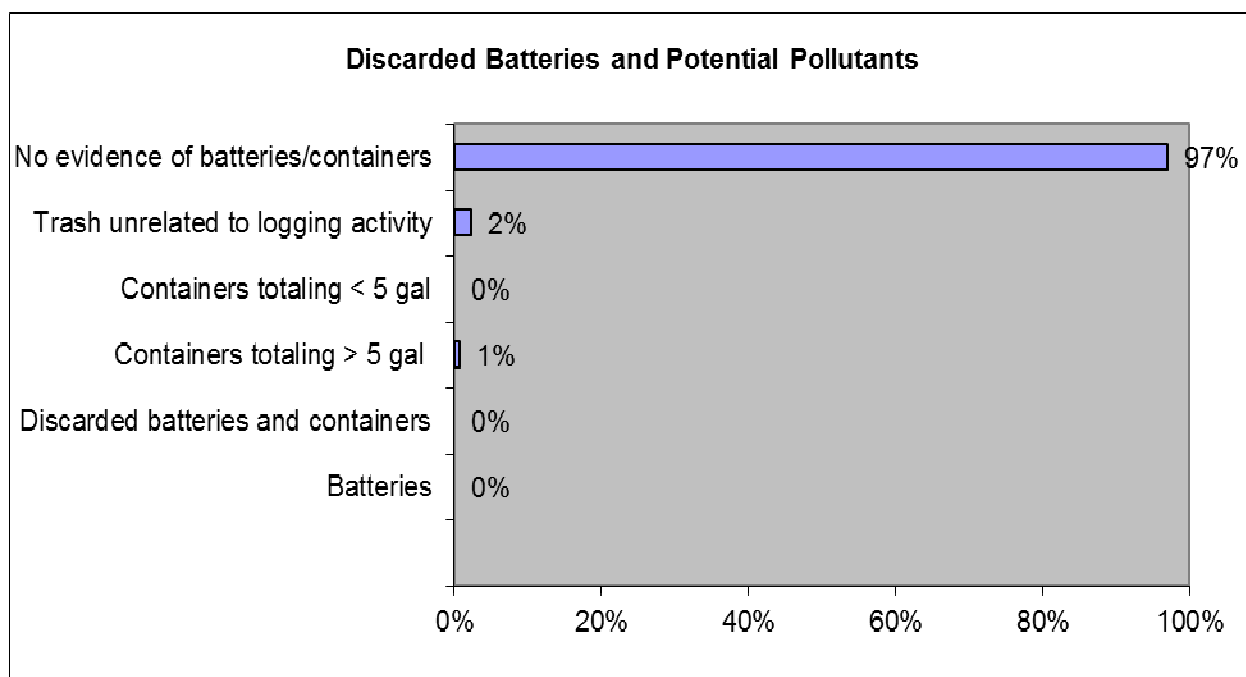
**Figure 32.** Discarded batteries and other pollutants (n=134).

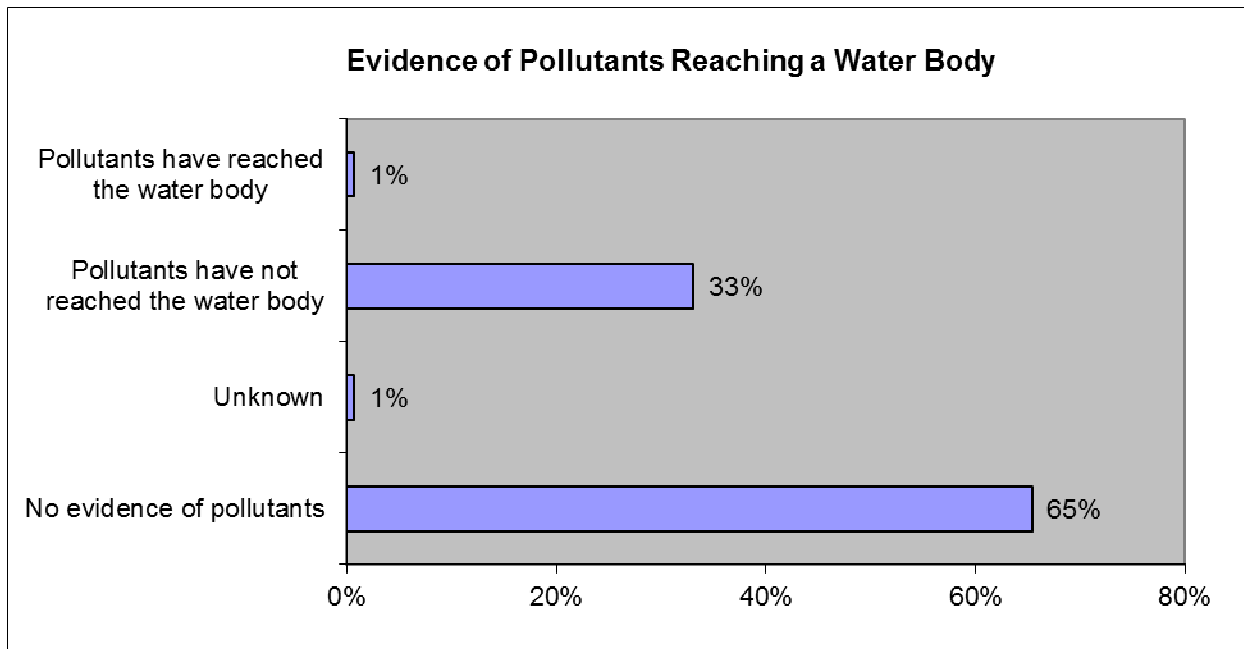
**Figure 33.** Evidence of pollutants reaching a waterbody (n=134).

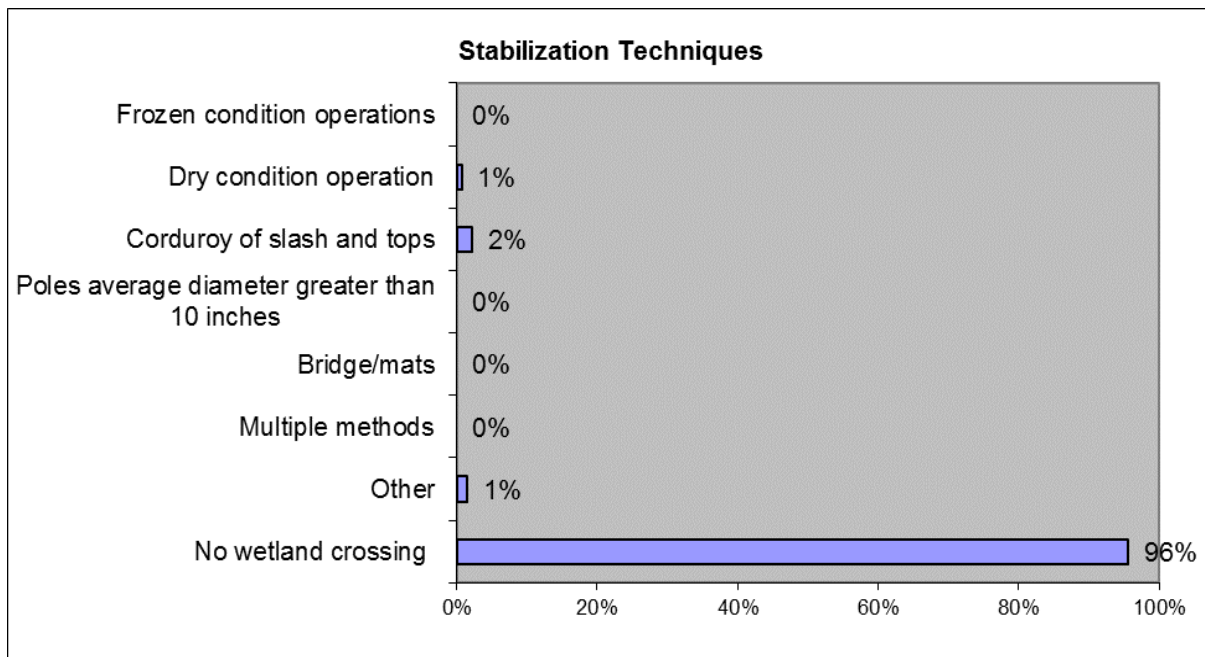
**Figure 34.** Wetland crossing stabilization techniques (n=134).

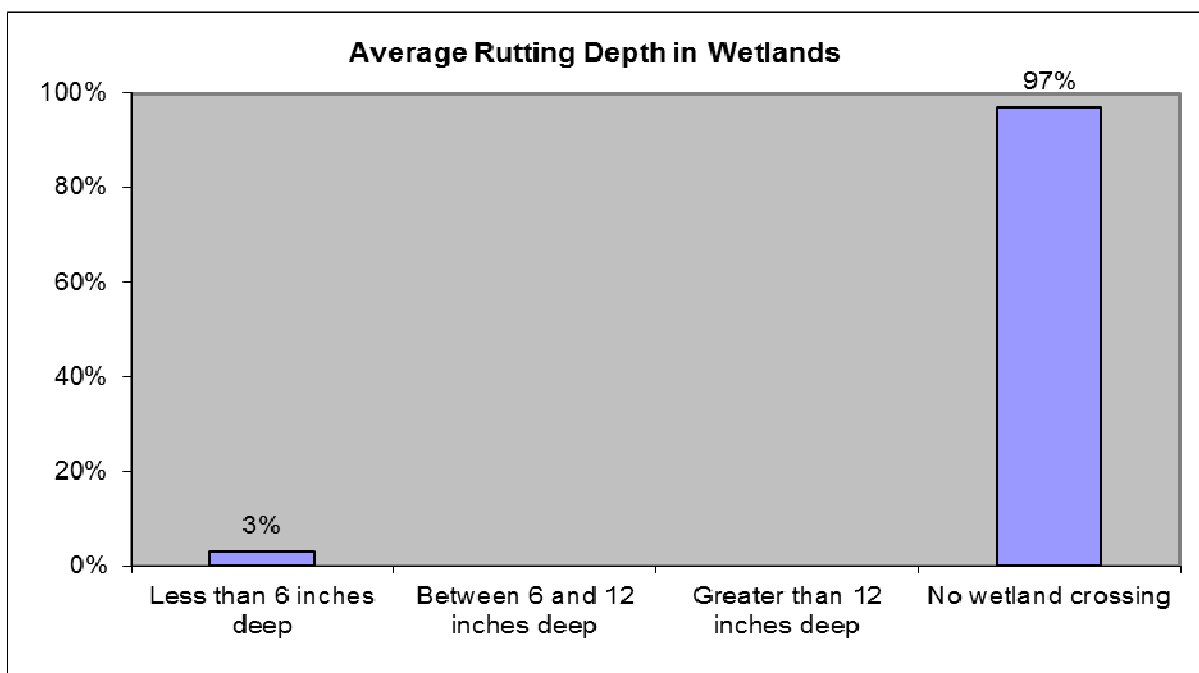
**Figure 35.** Average rutting depth in wetlands (n=134).

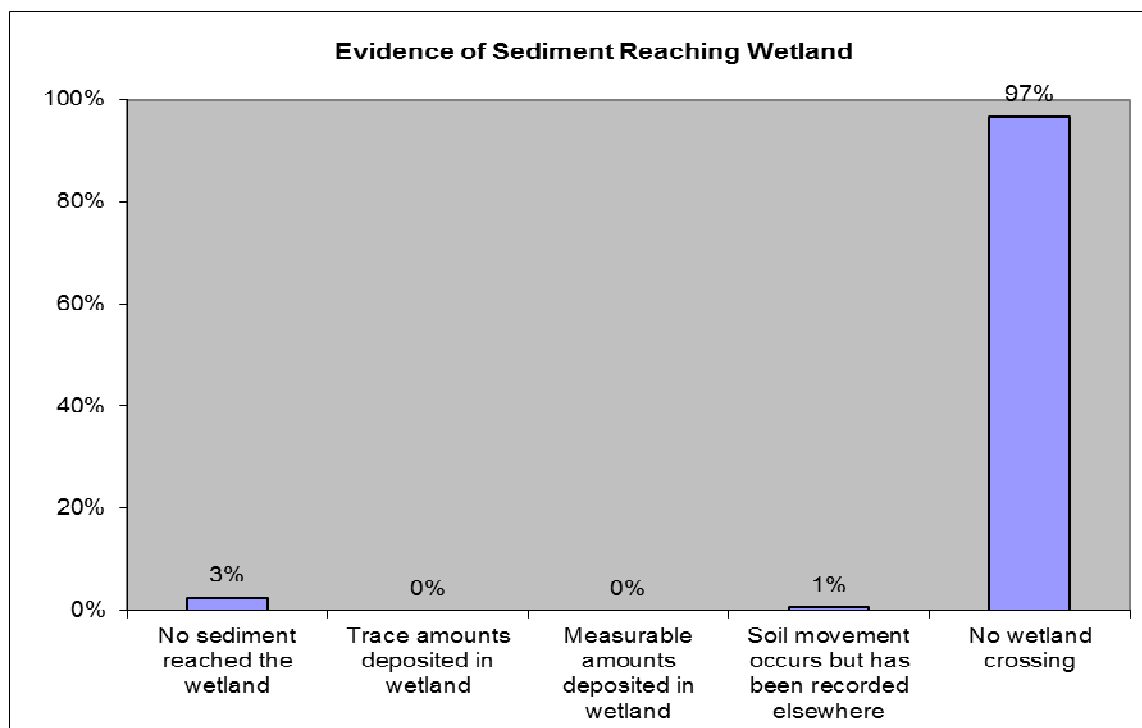
**Figure 36.** Evidence of sediment reaching wetlands (n=134).
